Pedestrian Safety

Initiative Meeting #4
January 30, 2009

Piney Branch HIA: Timeline of Activities

Piney Branch HIA: Summary of Audit Findings

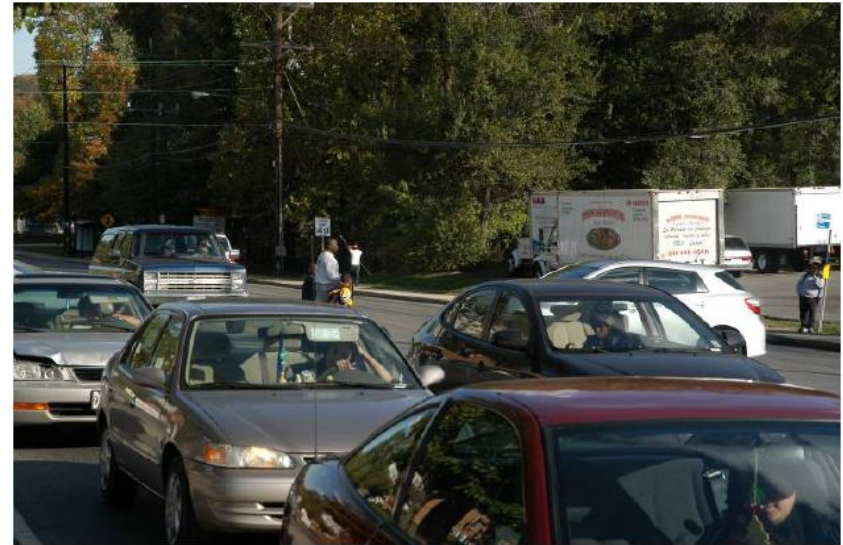
Multiple conflicts at driveways

- Access points to Panam Latino Market and LA Market act like an intersection with no traffic control.
- Left turning traffic from all directions is heavy.
- Access points interfere with sidewalks and the high number of pedestrians that use them.
- Driver's attention focused on finding gaps in traffic - less attention to pedestrians.

Multiple conflicts: Parent crossing with his children while cars are turning left in/out of driveways.

- Relocating the access point from the Panam Latino Market further north (across from the church driveway) to reduce conflicts at this location.

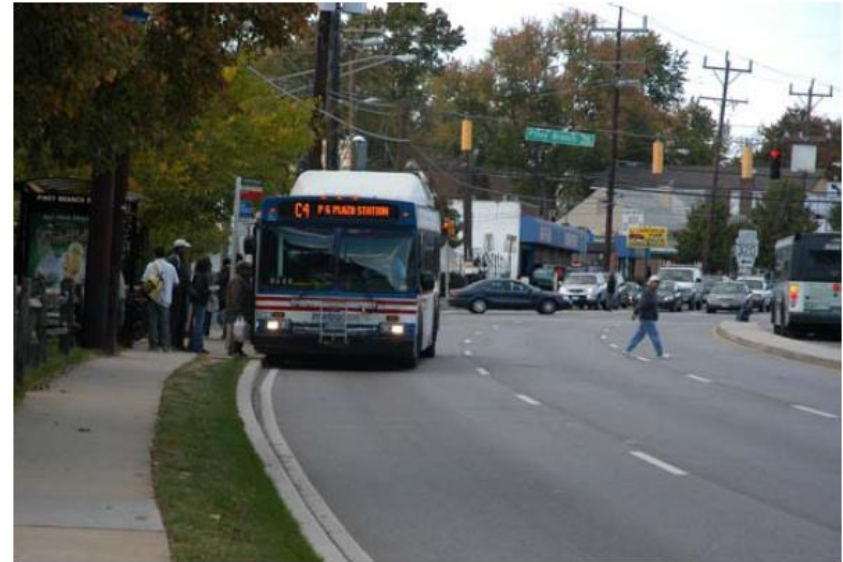
Mid-block pedestrian crossings

- Pedestrians often trace the shortest or most convenient paths.
- High numbers of pedestrians were observed to cross midblock at this location primarily to access the bus stops and also to the stores located on either side of Piney Branch Road.

Pedestrian crossing midblock after disembarking a bus between Piney Branch Road and Seek Lane on University Boulevard

- Extend the raised median north of University Blvd.
- Install a pedestrian barrier along the entire section of the raised median.
- Relocate the northbound bus stop closer to University Blvd. to encourage crossing at the intersection.
- Consolidate the southbound bus stop with the bus stop on the far side of the intersection to encourage crossing at the intersection.

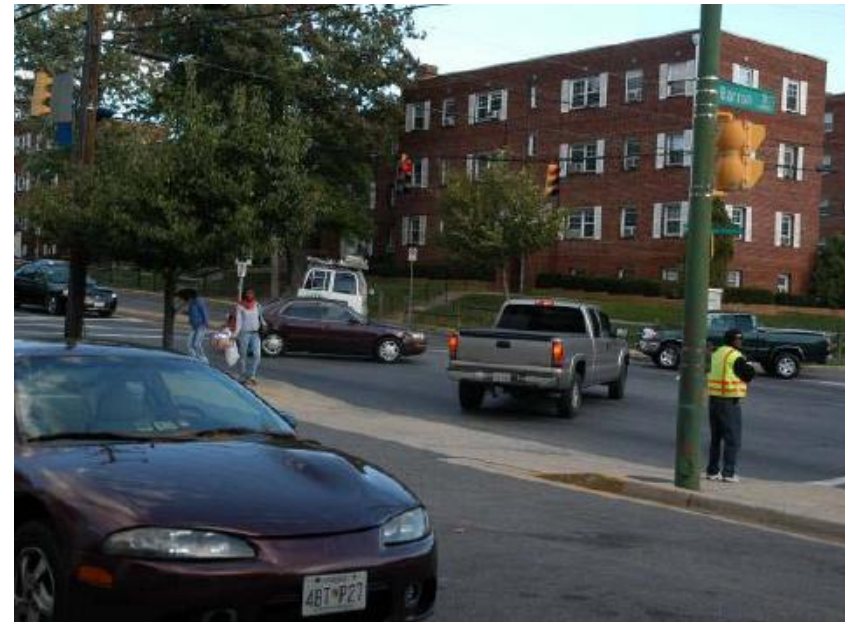
Conflicts caused by multiple access points

- There are three driveways on the west side of the intersection that allow vehicles to enter/exit road.
- There is no traffic control for driveways.
- Vehicles exiting the driveways conflict with each other and with pedestrians.

Vehicles turning left and right from the Sterling Dentistry driveway and left from the Miles Glass Co. driveway on the west side of Piney Branch Road.

- *Short term:* Consider making the driveways right-in and right-out and relocating the crosswalk on the north side.
 - *Pro:* Left turn conflicts from driveways are eliminated
 - *Con:* Channels reduce effective sidewalk width which may cause pedestrians to walk through parking areas.
- *Long term:* Consider consolidating the three access points into one driveway and provide traffic signal control. Relocate crosswalk.
 - *Pro:* Multiple conflicts from driveways are eliminated
 - *Con:* Extensive coordination with business owners, loss of some parking.

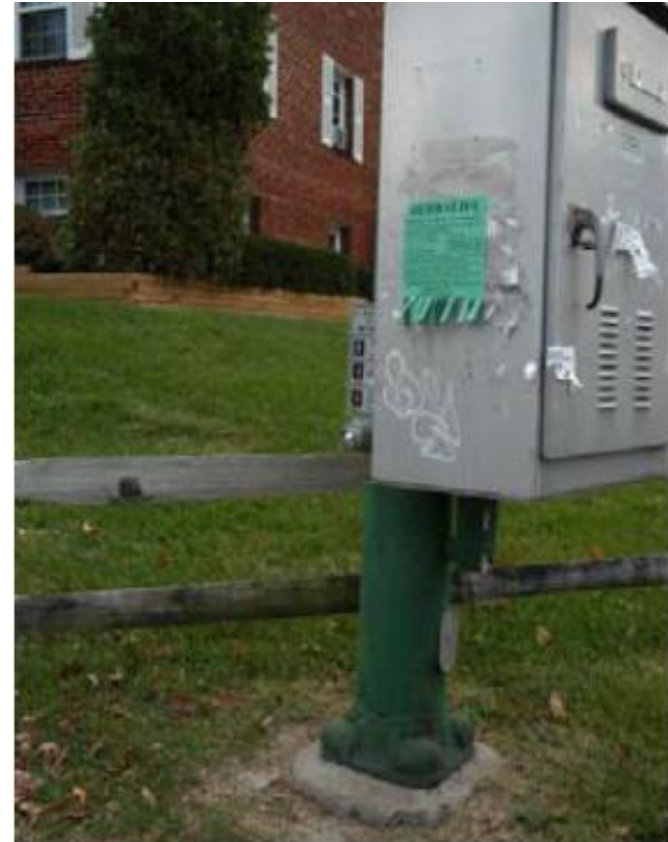
Improper location of pedestrian push button

- Pedestrian push button for the crosswalk on the north side of this intersection is hidden behind the traffic controller box.
- This push button is not accessible and may reduce the compliance of pedestrians using the push button to activate the pedestrian signal at this location.

Photo of pedestrian push button in the northeast corner of Barron Street and Piney Branch Road hidden behind the traffic controller box

- Consider installing a post-mounted accessible pedestrian push button.

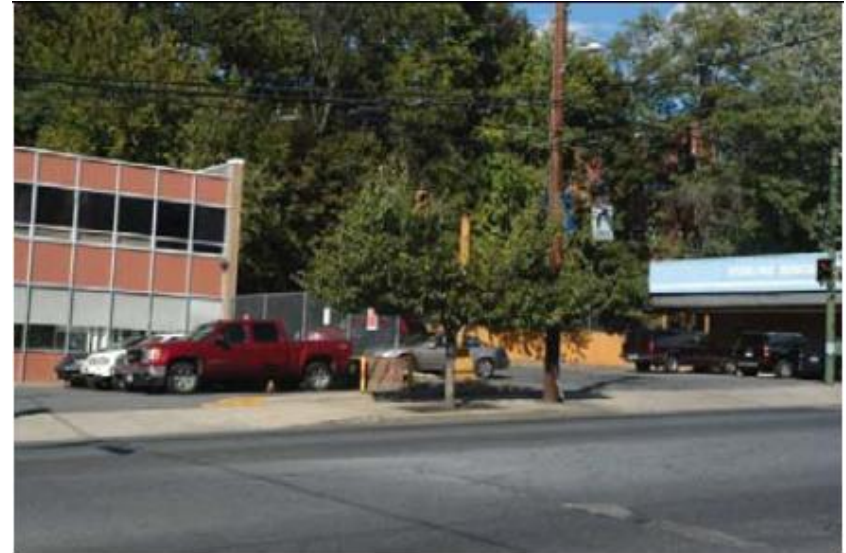
Traffic signals hidden by trees

- Traffic signal heads for westbound Barron Street were blocked by trees.
- Vehicles yielding to pedestrians while making a left turn from Barron Street to go southbound on Piney Branch Road are not able to see the signal head.

Photo showing the tree blocking the traffic signal heads for Barron Street at Piney Branch Road.

- *Short term:* Consider trimming the tree to improve the visibility of the traffic signal heads.
- *Long term:* As part of consolidating the driveways on the west side of the intersection, install the signal heads at appropriate location.

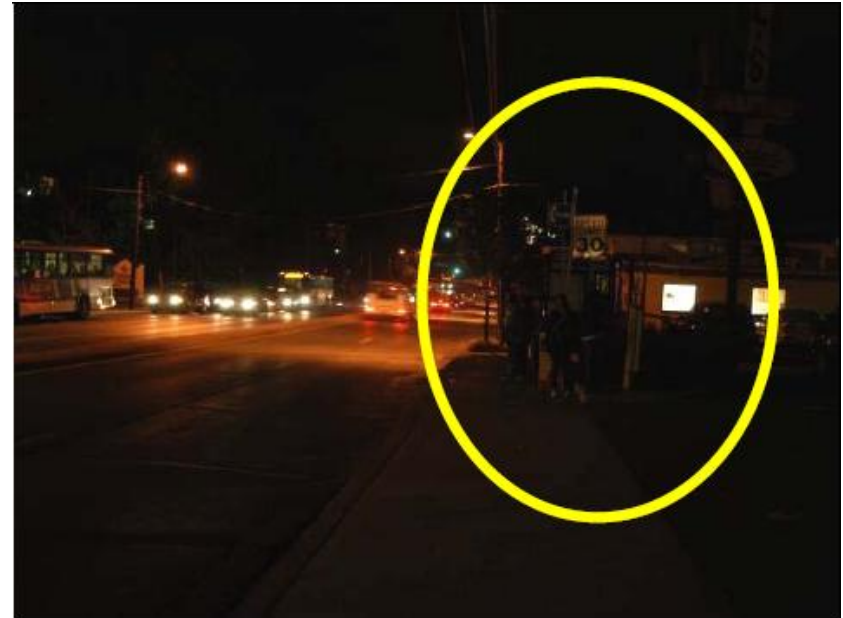
Poor nighttime visibility

- The section between Barron Street and University Boulevard was observed to have poor night time visibility.
- Pedestrians crossing the street, especially midblock after disembarking buses were not seen by drivers until they were very close, causing the drivers to react on a very short notice.
- A resident noted this problem to the Road Safety Audit team during the field visits.

Night time photo showing transit riders waiting at the bus stop between Barron Street & University Boulevard in the southbound direction

- Ensure consistent level lighting between Barron Street and University Boulevard.
- Repair or replace the street lights between Barron Street and University Boulevard.
- Ensure that the bus shelters near Barron Street are lit.

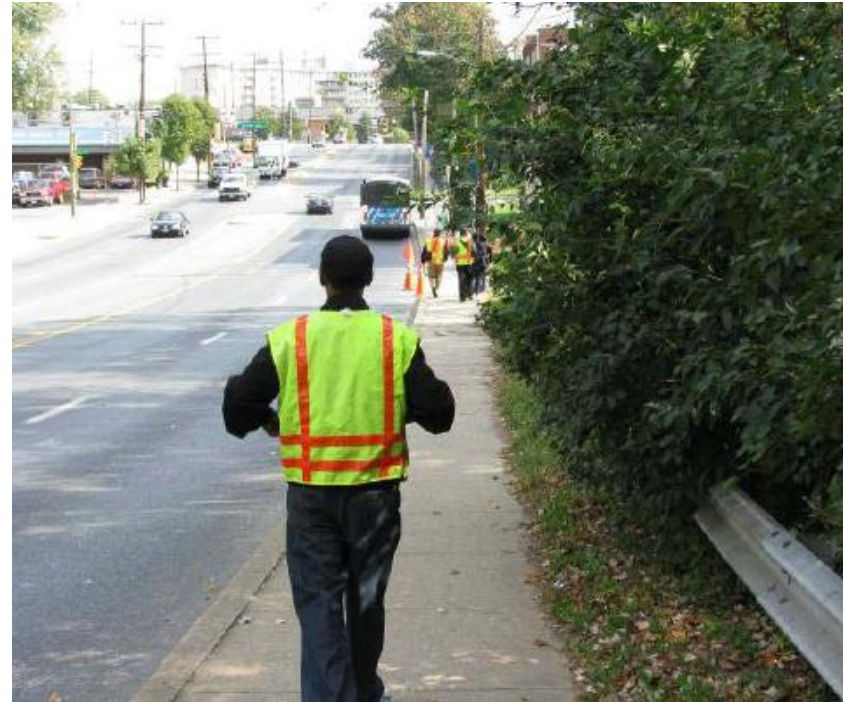
Sidewalk width

- Sidewalk on the eastside of Piney Branch Road between Garland Avenue and Barron Street is only 4' wide.
- Overgrown vegetation and foliage along side of the sidewalk appears to reduce the effective width of the sidewalk as does the lack of a buffer from travel lanes.

Narrow sidewalk on the east side of Piney Branch Road between Garland Avenue and Barron Street

- Consider widening the sidewalk to 5 feet minimum to meet the ADA requirements. If possible, widen sidewalks to a minimum of 6 feet throughout the corridor.
- Trim vegetation to improve the effective sidewalk width.

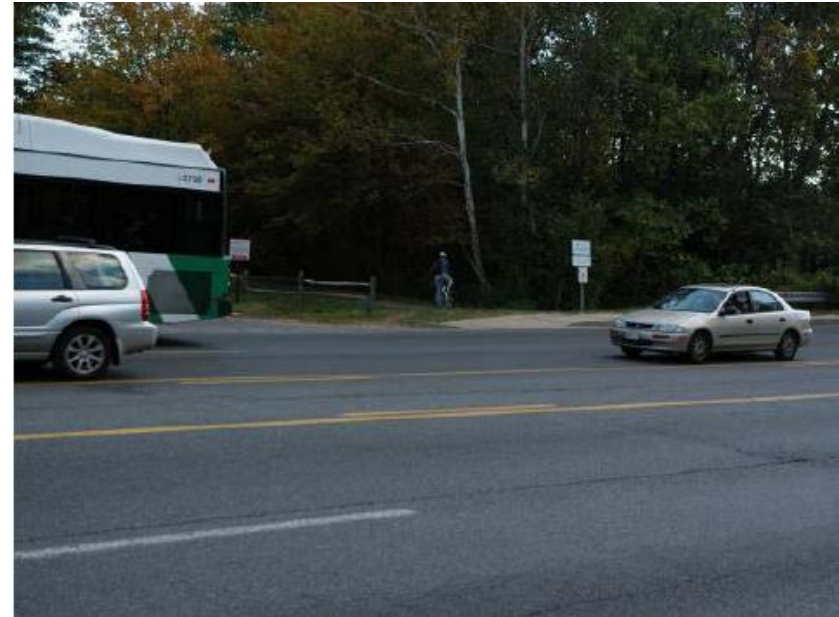
Lack of direct connection to the Long Branch bike trail

- Piney Branch Road intersects the northern portion of Long Branch bike trail near the Long Branch Community Center.

Photo showing the section of Piney Branch Road at the Long Branch bike trail near Long Branch Community Center

- A direct connection for trail users is not provided; the nearest crossing is at Barron Street.
- Consider installing wayfinding signs to direct trail users to cross at Barron Street once enhancements are made to the intersection.

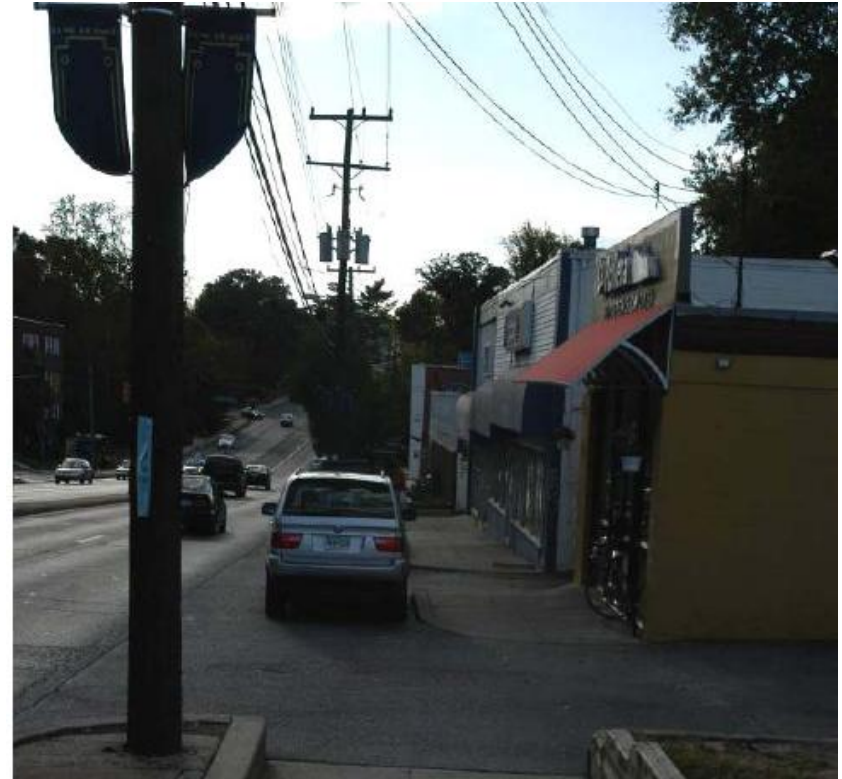
Lack of delineation between travel lanes and parking lane

- Pocket parking is provided along the southbound lanes of Piney Branch Road between University Boulevard and Barron Street.
- There is no delineation between the travel lanes and the parking lane.

Parking in front of the Pupuseria Restaurant between University Boulevard and Barron Street not delineated from the southbound travel lanes

- Provide white edge line markings to delineate the travel lane and the parking lane.

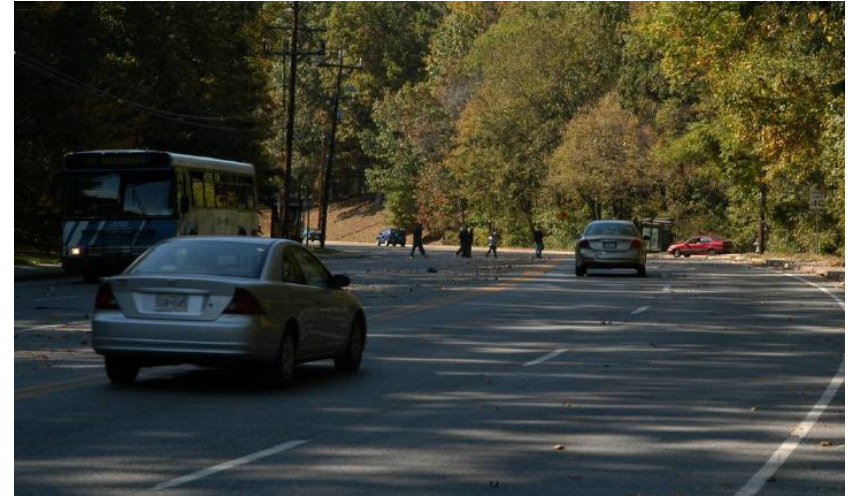
Long distances between crossings

- The closest marked crosswalk for Nob Hill Apartments is approximately 900 ft away at Carroll Avenue
- For the Forest Park Apartments, the closest is approximately 1200 ft away at New Hampshire Avenue.

Poor sight distances

- Sight distances for vehicles existing Nob Hills Apartments and Forest Park Apartments are limited by horizontal and vertical curves.

Pedestrians crossing towards Nob Hill Apartments after disembarking a bus

- (short-term) A raised median refuge area at the two apartment access points north of Carroll Ave.
- (long-term) Consolidate bus stops
- (long-term) Two-stage signalized crossing
- Relocate the advance warning signs farther upstream.

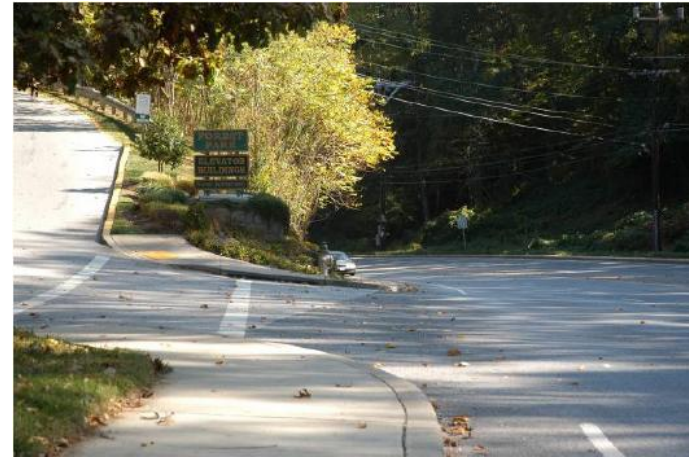
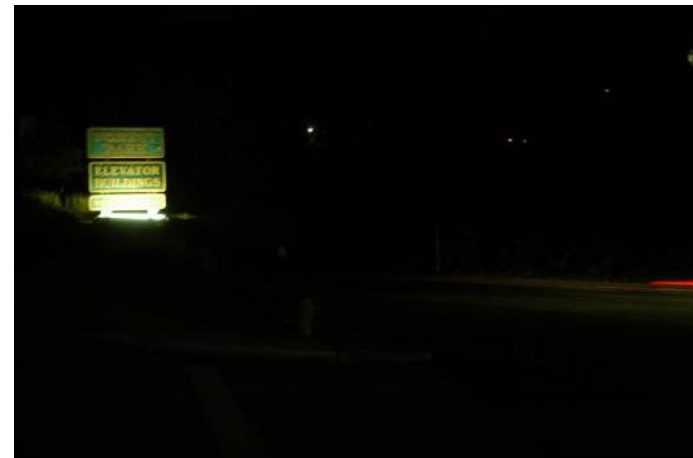
Poor nighttime visibility

- Nighttime visibility on Piney Branch Road to the north of Carroll Avenue is poor.
- Street lights especially near the bus shelters are spaced too far apart.
- Pedestrians crossing the street at these locations after dark are not visible to the drivers and are at higher risk for a collision.

Day and night photos of same location near Forest Park Apartments

- Consider installing additional street lights to decrease spacing.
- Repair/replace the street lights that are not working.
- Ensure that the bus shelters are lit.
- Consider installing raised pavement markers to provide positive guidance for drivers.

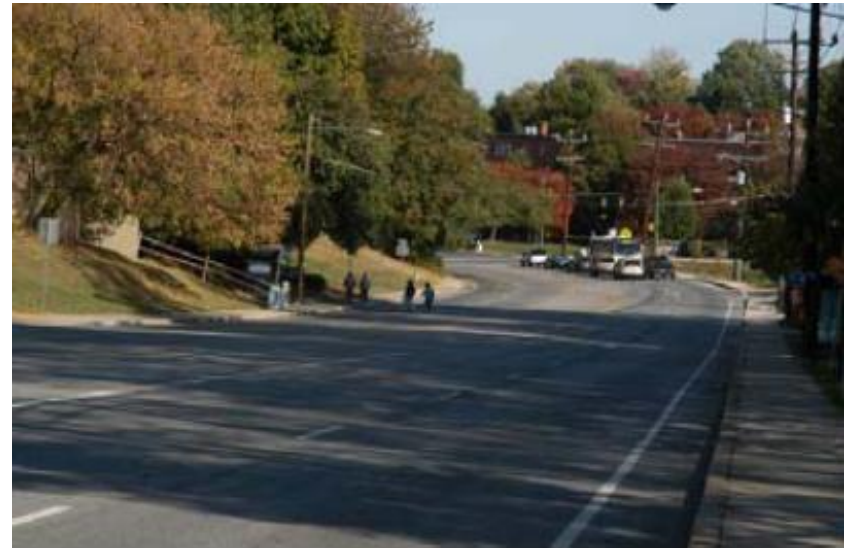
Mid-block pedestrian crossings

- Pine Way Towers and Park Montgomery Apartments are high rise apartments with residents that depend on transit.
- The distance between the two closest crossings, at University Boulevard and Carroll Avenue, is approximately 1300 feet.
- Entrance to the New Hampshire Estates park is located between Pine Way Towers and Park Montgomery Apartments along the east side of Piney Branch Road.

Pedestrians crossing midblock from New Hampshire Estates park to Park Montgomery Apartments

- Consider installing a midblock crosswalk with a median refuge and flashing beacons between Pine Way Towers and Park Montgomery Apartments.
- Consider reducing posted speeds in conjunction with the midblock crosswalk between Pine Way Towers and Park Montgomery Apartments to reflect the commercial, high-pedestrian use nature of the roadway (reduce posted speed from University Boulevard to Carroll Avenue).

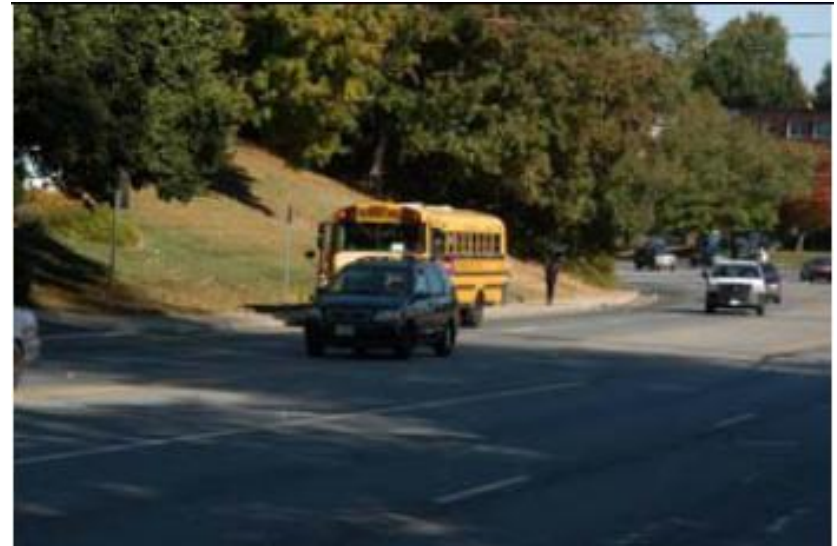
Vehicles not stopping for school buses

- The Road Safety Audit team noticed that vehicles were not stopping for a stopped school bus with flashers.

Photo showing vehicles not stopping for a school bus in the same direction with flashers on

- Relocate the existing “STOP FOR SCHOOL BUS WHEN RED LIGHTS FLASH” sign in the northbound direction closer to the roadway and install a same sign for the southbound direction.
- Implement driver education programs through various community based programs and centers such as CASA.
- Increase enforcement along this section of roadway during school pick-up and drop-off periods.

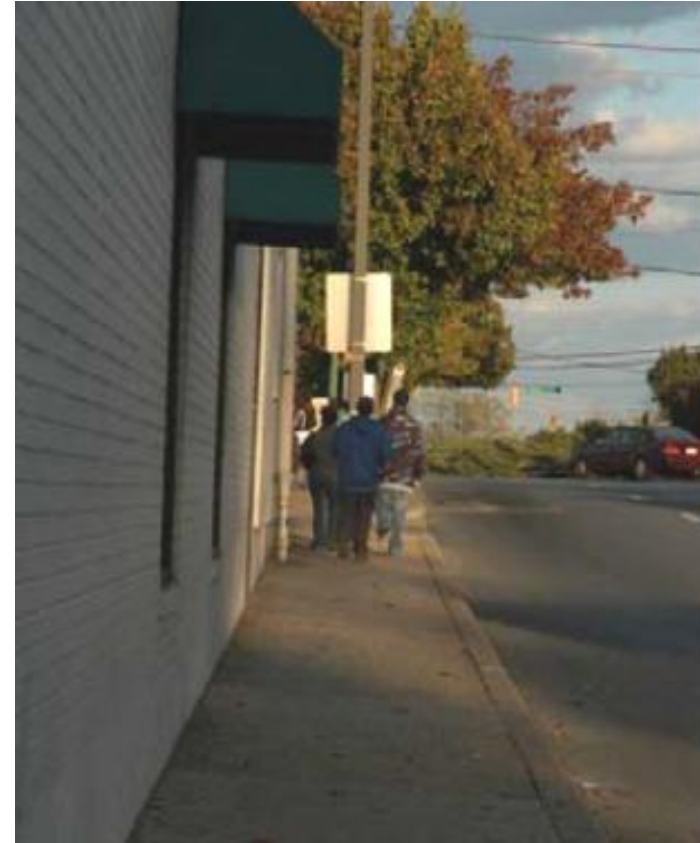
Sidewalk width

- Sidewalks along the western side of Piney Branch Road are narrow for the amount of pedestrian activity.
- The effective width of the sidewalk is reduced by two factors:
 1. The proximity to the building.
 2. The lack of a buffer between the sidewalk and travel lanes.

Narrow sidewalk adjacent to the wide southbound travel lane.

- Consider creating a wider sidewalk possibly with a buffer on the west side by narrowing the wide southbound outside lane.

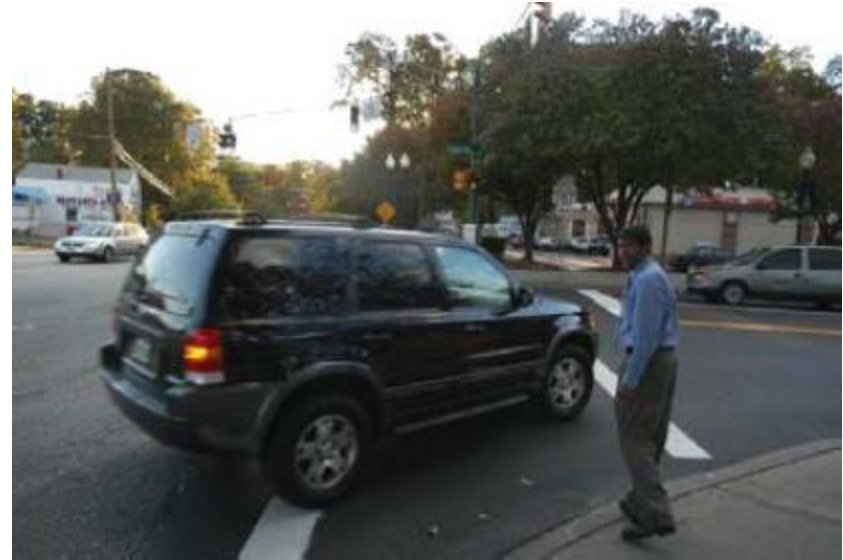
Right turning vehicles not yielding to pedestrians in crosswalk

- Southbound right turns from Piney Branch Road onto Flower Avenue are observed to not yield to pedestrians in the crosswalk or beginning to cross.
- A combination of vehicles traveling at high speeds and limited visibility at the corner may be contributing factors.

Photo of a driver failing to yield to pedestrian beginning to cross the street in the crosswalk

- Consider widening sidewalk.
- Consider reducing corner radius slightly on the northwest corner of the intersection to reduce vehicle speeds and create greater sight distance between pedestrians waiting to cross and turning vehicles.

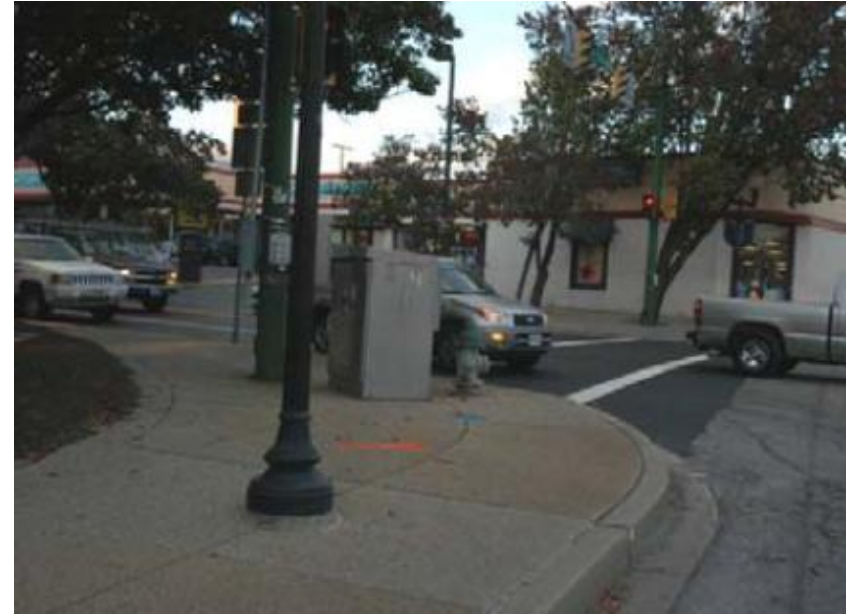
Obstructed view of pedestrians in the sidewalks

- Sight obstructions (i.e. traffic control box) block the view of the pedestrians in the crosswalk.
- The crosswalk on the south leg is located far away from the intersection where motorists may not be focused on pedestrians.

View of sight obstructions from the crosswalk on the south leg

- Consider relocating the traffic controller box off of the sidewalk.
- Consider moving the crosswalk closer to the intersection.

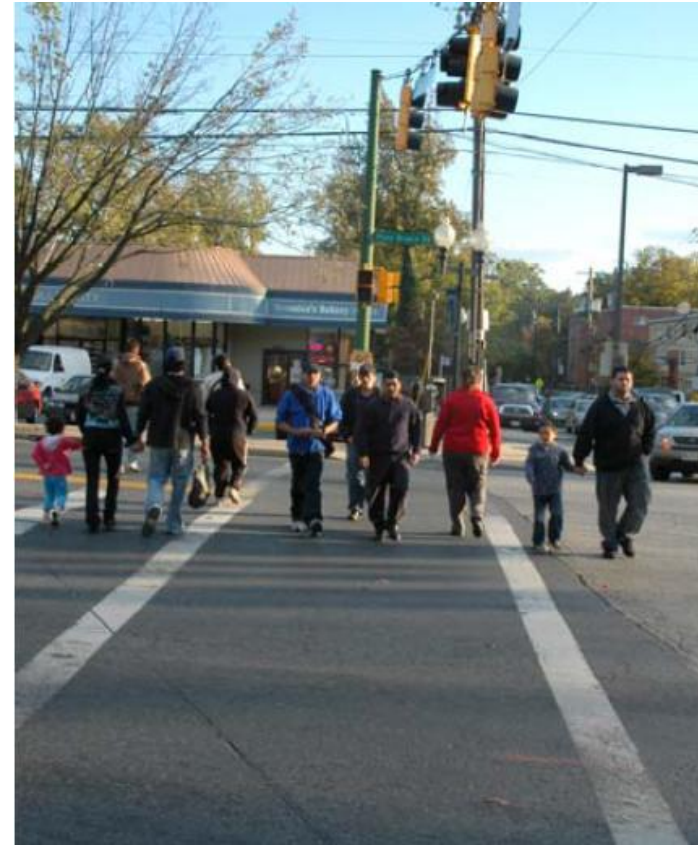
Conflicting left turning traffic with pedestrians

- Eastbound left turn phase is a permissive left turn phase and there are a high number of pedestrians using the north side crosswalk which may result in a pedestrian vehicular conflict.
- Pedestrians must walk outside of the crosswalk due to the large volume of pedestrians crossing further exposing them to vehicle conflicts.

Pedestrians crossing the crosswalk on the north leg conflict with right and left turning traffic

- Consider installing a protective/ permissive left turn phase for eastbound Flower Avenue.
- Consider using wayfinding techniques to northbound Piney Branch Road from eastbound Flower Avenue at Arliss Street to reduce left turning traffic at this intersection.
- Consider widening and installing high visibility crosswalk.

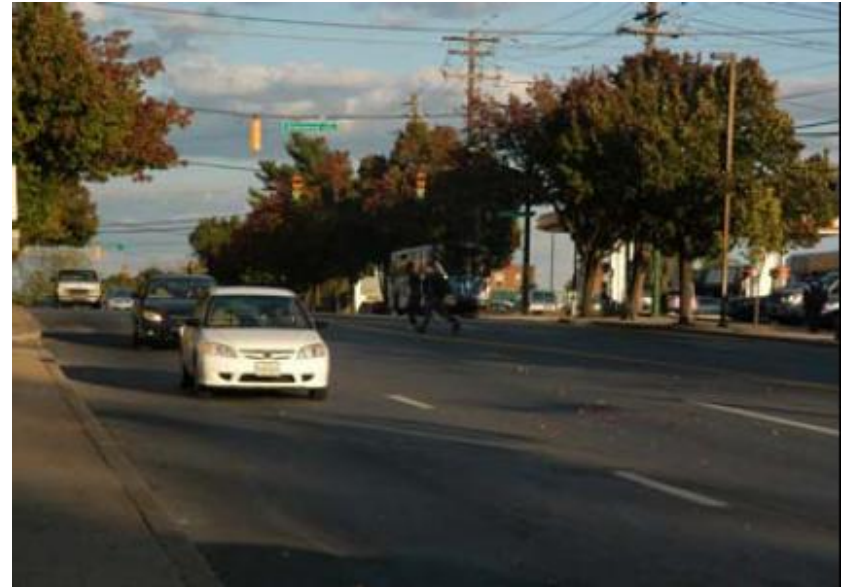
Mid-block pedestrian crossings

- High number of pedestrians were observed crossing midblock at the location of bus stops between Flower Avenue and Greenwood Avenue.

Pedestrian crossing midblock after disembarking a bus between Flower Avenue and Greenwood Avenue.

- Consider relocating the bus stop for the northbound direction to the far side of the intersection of Greenwood Avenue and Piney Branch Road.
- Consider relocation the bus stop for the southbound direction to the far side of the intersection of Greenwood Avenue and Piney Branch Road.

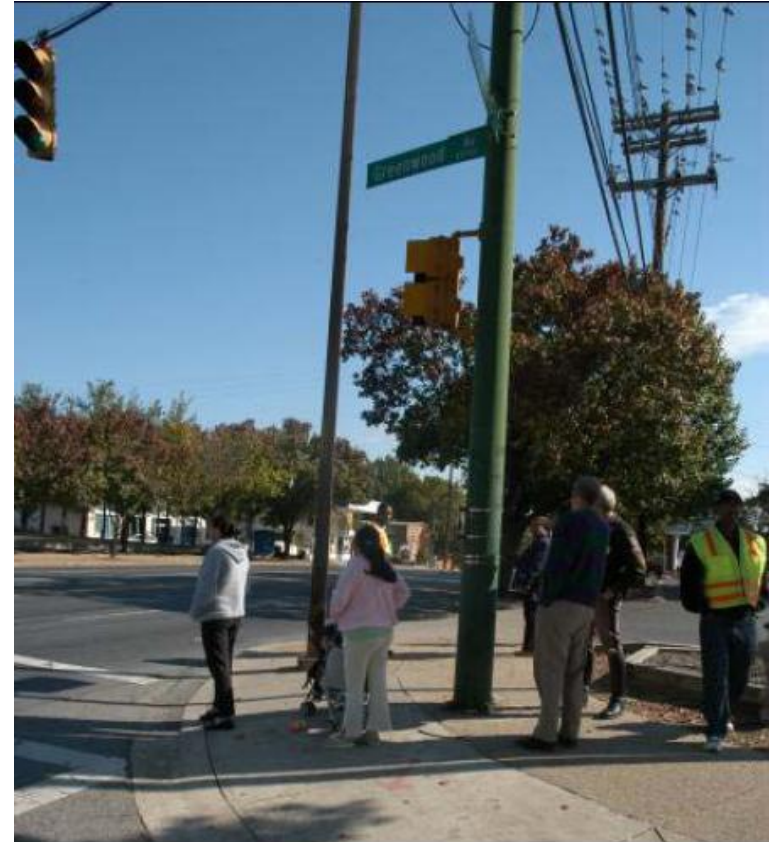
Lack of pedestrian signals parallel to Piney Branch Road

- Pedestrian signal heads are missing for approaches parallel to Piney Branch Road. This may result in pedestrians crossing with conflicting traffic.

Photo showing lack of pedestrian signals crossing Greenwood Avenue and also curb ramps that have excessive slope at the northeast corner of the intersection

- Consider installing countdown pedestrian signal heads parallel to Piney Branch Road.

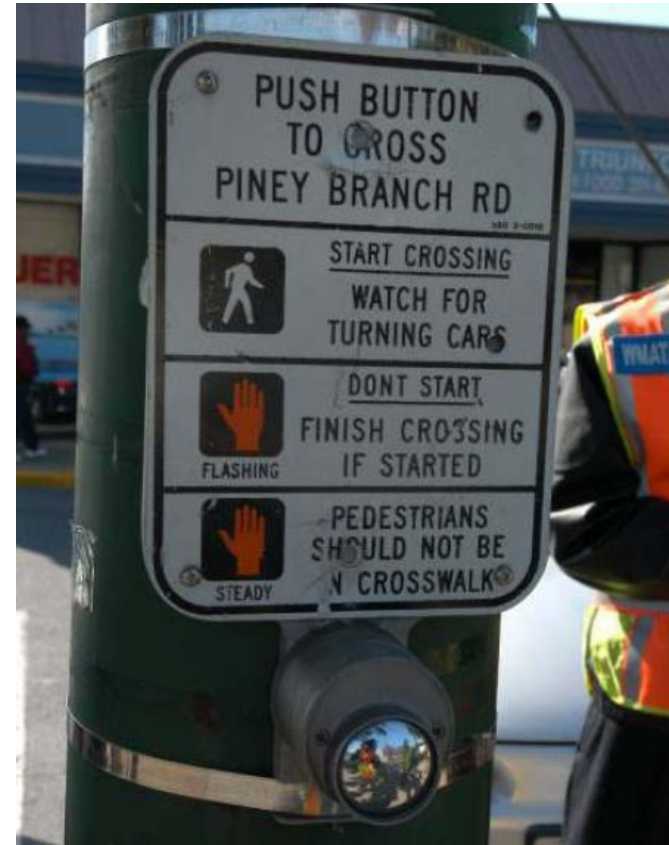
Inactive pedestrian push buttons

- Pedestrian push buttons at this intersection are inactive, which will discourage proper use of push button devices.

Inactive pedestrian push buttons at the southeast corner of Greenwood Avenue and Piney Branch Road

- Ensure the pedestrian push buttons are in working condition at all four corners.
- Consider upgrading push buttons to the type that confirms the press.

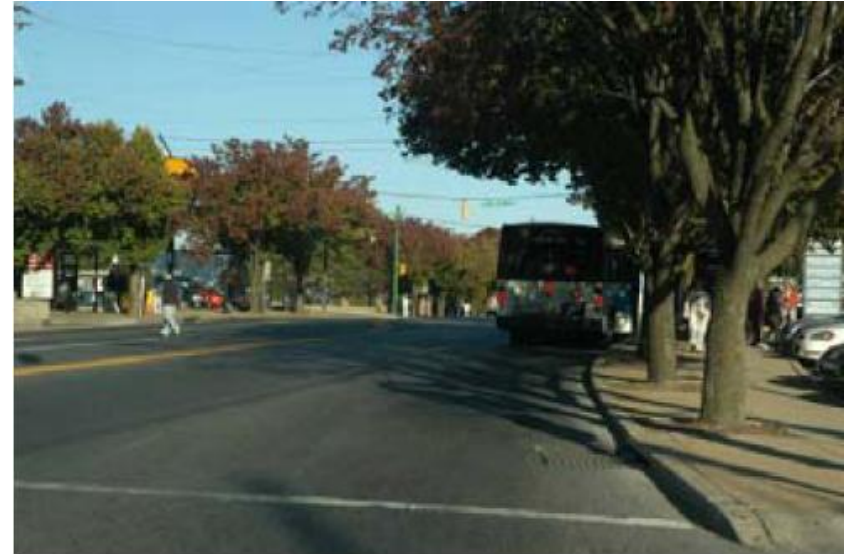
Traffic signals blocked by trees

Traffic signal heads cannot be seen from the outside lane on Piney Branch Road

- Consider trimming the tree to improve the visibility of the traffic signal heads.

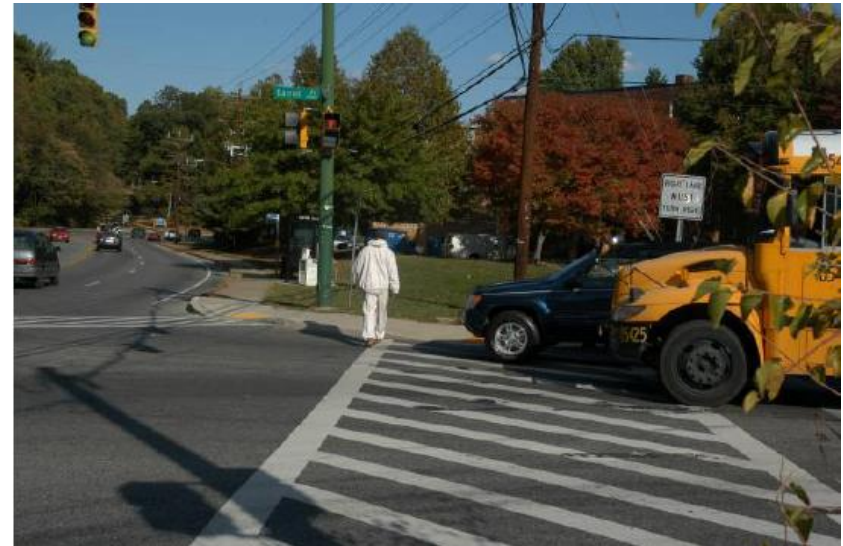
- Vehicles were observed to not yield to pedestrians in the crosswalk.
- Vehicles in the westbound left turn lane seem to be blocking the view between the pedestrians and right turning vehicles potentially creating a major conflict between them.
- This is especially critical as many of the pedestrians in this area were children, who may not perceive this threat and who present a smaller profile to motorists.

School bus in the westbound left turn lane on Carroll Avenue blocked the view between the pedestrian and the right turning vehicle

- Consider reducing speeds south of Carroll Avenue in conjunction with the suggested midblock crosswalk between Pine Way Towers and Park Montgomery Apartments.
- Consider installing “No Right Turn on Red” on northbound and westbound approaches.

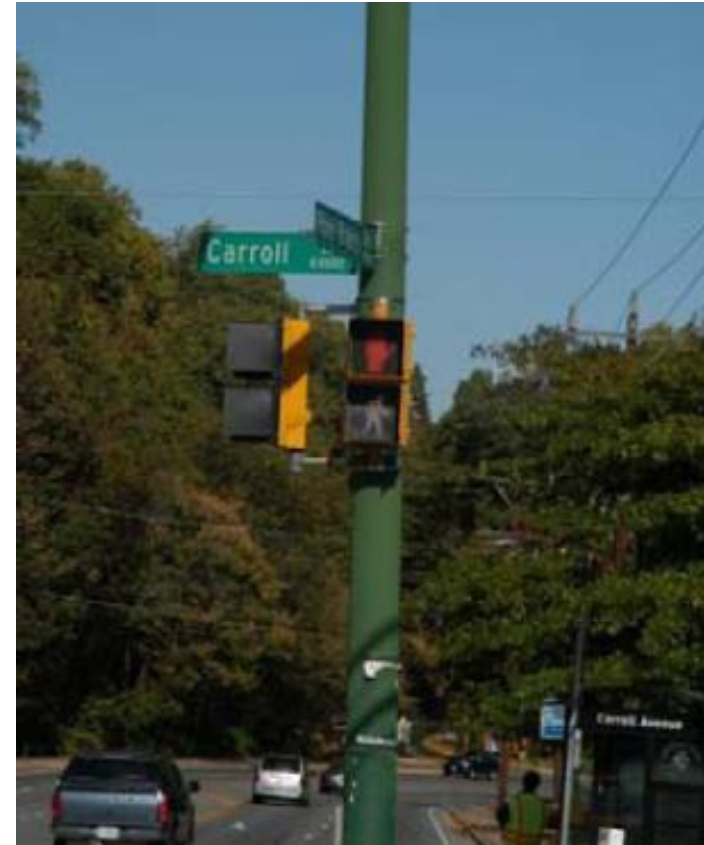
Faded signal heads for the crosswalk on the eastside are difficult to read, especially with the sun glare on them

- Consider replacing the old pedestrian signal heads with LED countdown pedestrian signal heads.

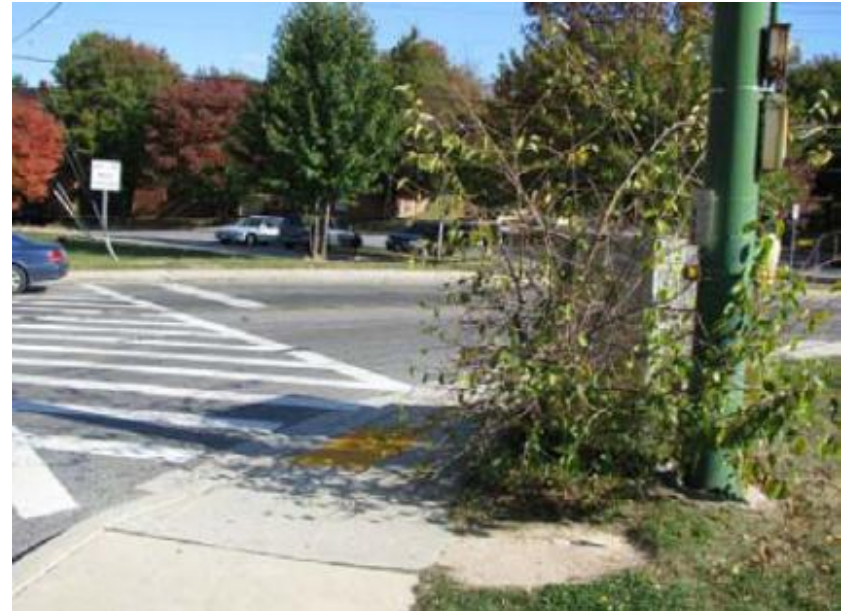
Photo showing the overgrown vegetation at the southeast corner of Carroll Avenue and Piney Branch Road

- Trim vegetation to improve accessibility to the push button.

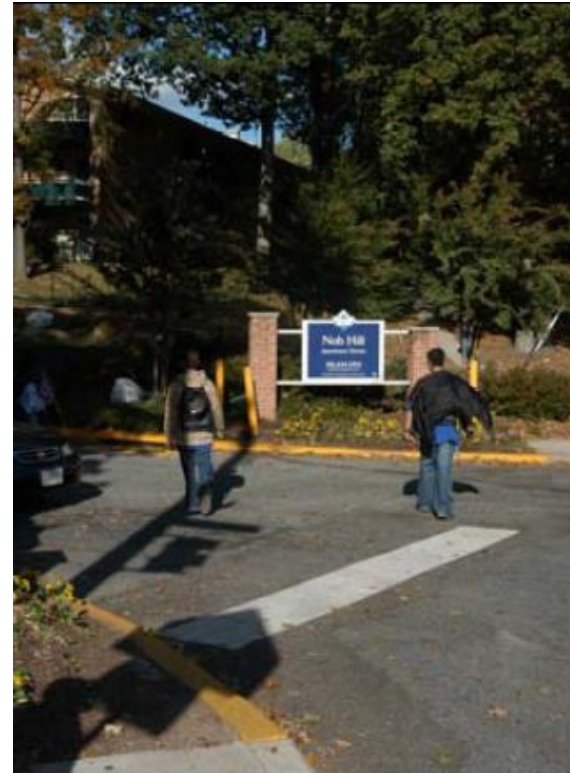
Missing crosswalk marking on west leg

Photo showing pedestrians crossing intersection to Nob Hill Apartments

- Consider installing crosswalk marking on west leg of intersection.

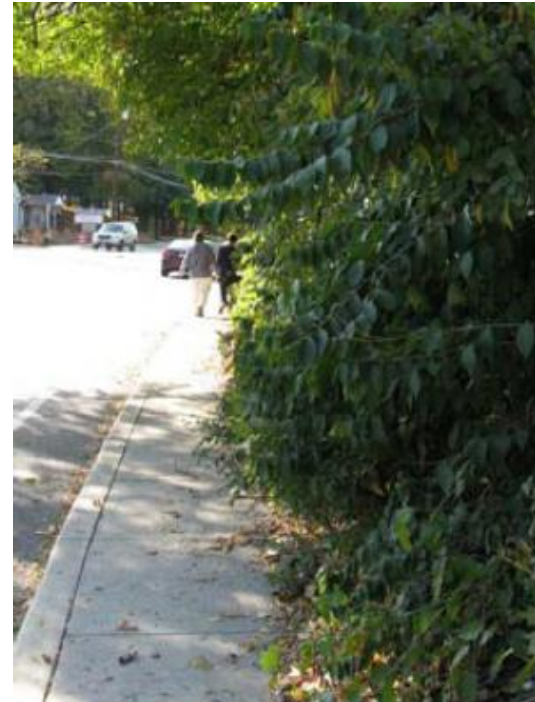
Sidewalk width

- Over grown vegetation and foliage along side of the sidewalk appears to be protruding into the sidewalk, reducing the effective width of the sidewalk.
- This condition can create accessibility issues for pedestrian with mobility restrictions and reduce the capacity of the sidewalk system.

Vegetation at this location has encroached on the sidewalk, narrowing its effective width and making it more difficult to use for pedestrians with mobility restrictions and groups of pedestrians

- Trim vegetation to improve the effective sidewalk width.
